FEAP-TR-FM-94/09  
June 1994

# Demonstration of a Field Rehabilitation Technique for Removing Corrosive Solder Flux in Cold Water Copper Piping Systems

by  
O.S. Marshall, V.L. Van Blaricum, R.H. Knoll, V.F. Hock, and J.R. Myers  
U.S. Army Construction Engineering Research Laboratories  
Champaign, IL 61826-9005

# **DEMONSTRATION OF A FIELD REHABILITATION TECHNIQUE FOR REMOVING CORROSIVE SOLDER FLUX IN COLD WATER COPPER PIPING SYSTEMS**

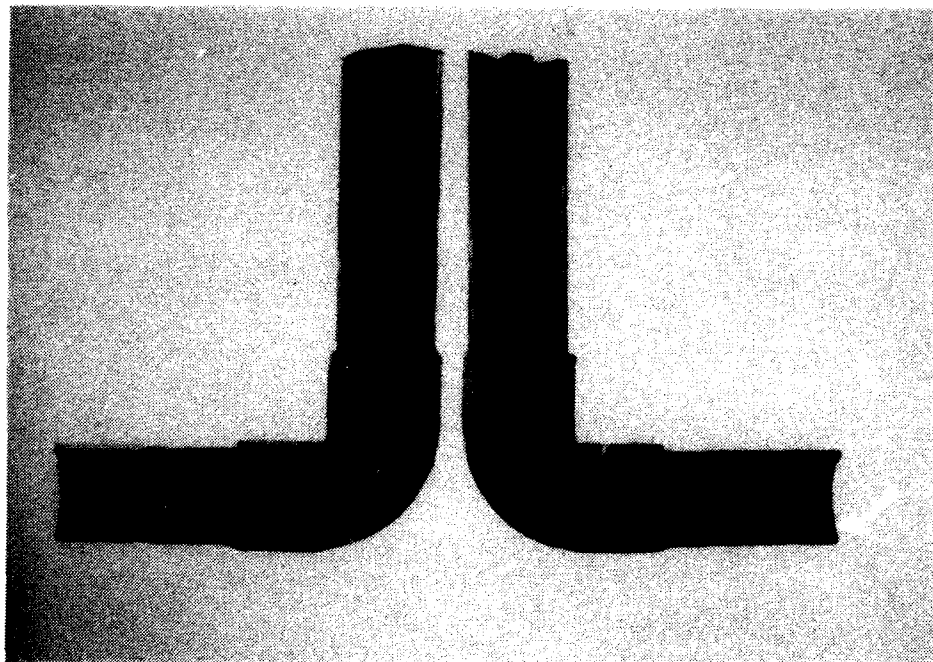
**Figure 4. Internal Surface of Specimen 3.**

Specimen 3 (Figure 4) contained a strip similar to specimen 1. Again, corrosion-induced pits contained reddish-brown cuprous oxide and were overlaid with friable, greenish-colored tubercles. Chemical composition of the deposits was similar to that of specimens 1 and 2. Zinc and chloride were also found in the corrosion products, which confirmed the belief that soldering flux was involved in the corrosion process.

In all three specimens, the area where pitting attack had not occurred was covered with a protective tarnish film of reddish brown to nearly black cuprous oxide. This film was generally overlaid with a thin layer of friable, greenish-brown products, which was a deposit from the water. Measurements in the areas where pitting had not taken place confirmed that the specimens still satisfied the wall thickness requirements set forth in American Society for Testing and Materials (ASTM) Standard Specification B88 for Seamless Copper Water Tube.

In summary, the 1985 study found that the corrosion problems in the analyzed specimens resulted from soldering flux residue. USACERL recommended that plumbers working on the base be encouraged to use industry standard practices when installing copper piping systems. For example, excessive flux and the use of unusually-aggressive fluxes (especially certain self-cleaning fluxes) must be avoided. Adhering to the general guidelines for tube installation, joint preparation, and soldering presented in the Copper Development Association's *Copper Brass Bronze Product Handbook* "Copper Tube for Plumbing, Heating, Air Conditioning and Refrigeration" could probably assist in preventing the recurrence of soldering flux-induced leaks.

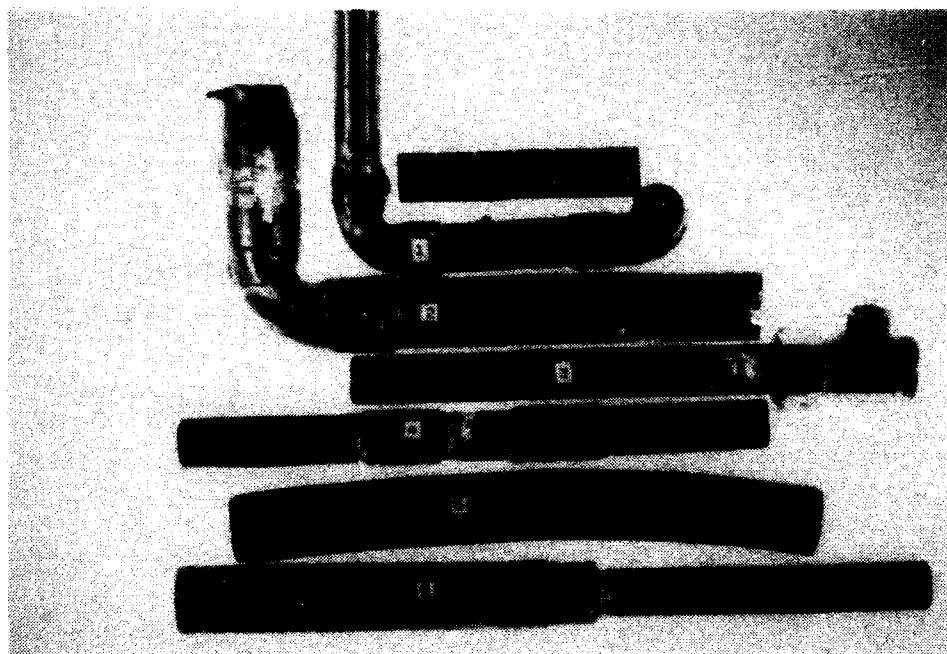
**Figure 5. External Surfaces of Specimens From 1987.**

A visual examination of the external surfaces of the specimens revealed no significant degradation by the external environment (Figure 5). The external surfaces of each specimen were covered with a protective tarnish film of reddish-brown cuprous oxide. Pinhole leaks had occurred in two of the specimens. Stereomicroscopic examination of the interior surfaces of the specimens showed that the pinhole perforations had initiated on the water (internal) side of the tubes.

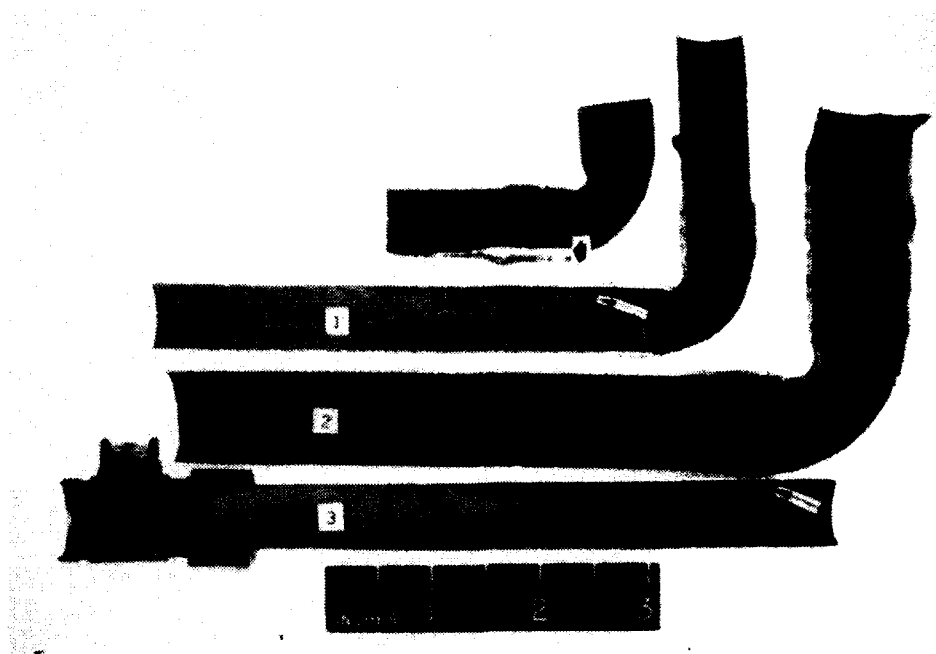
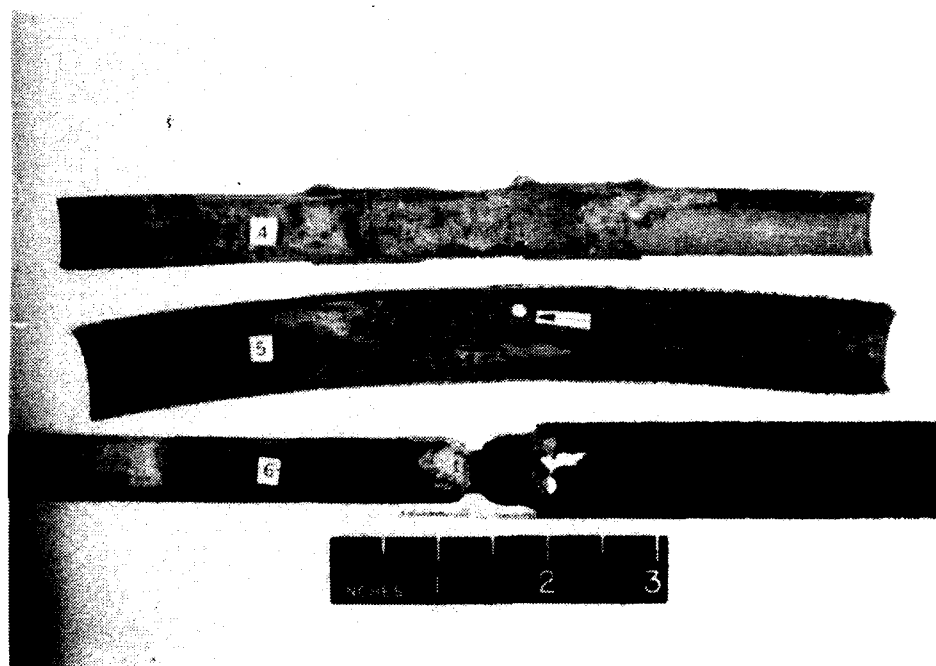
The specimens were sectioned lengthwise and their water-side surfaces were examined (Figures 6 and 7). The perforation in specimen 6 had been caused by erosion corrosion (accelerated attack related to localized, high velocity water inside the system). Most significant was the observation that soldering flux-related corrosion had occurred in all six of the specimens. Typically, the areas of corrosive attack were covered with voluminous, friable mounds of greenish-colored copper corrosion products. Porous cuprous oxide existed in the pits underneath these corrosion products. Sticky, petroleum-based soldering flux was found on the water-side surfaces of specimens 1 and 3. EDS analysis supported the belief that the localized corrosion had been induced by soldering flux; chlorides were found in the copper corrosion products. As discussed earlier, soldering fluxes typically contain activating chlorides. In addition, EDS analysis revealed the presence of lead and tin in the soldering flux runs, which indicated that a paste type solder (finely granulated solder suspended in a paste flux) had been used when the tubes and fittings were installed. On areas of the water-side surfaces where corrosion had not taken place, the copper was covered with a protective tarnish film of reddish-brown cuprous oxide. In general, the film was overlaid with a

thin layer of greenish-colored copper corrosion products that appeared to be a deposit from the water. It is likely that the source of the greenish-colored products was the soldering flux-induced corrosion of copper occurring upstream in the system.

After this study, it was concluded that the primary cause of Fort Stewart's corrosion problem in domestic cold water piping was the presence of soldering flux residue on the interior surfaces of the copper tubes and fittings. This conclusion was supported by the following facts: (1) soldering flux runs were found in almost all of the specimens that were analyzed in both investigations; (2) chlorides were found in the corrosion products; (3) the pitting corrosion problem only seemed to manifest itself in cold water piping systems (hot water tends to flush away the excess flux over time); and (4) the amount of time from system installation to failure was typical for pipes undergoing flux-induced corrosion.

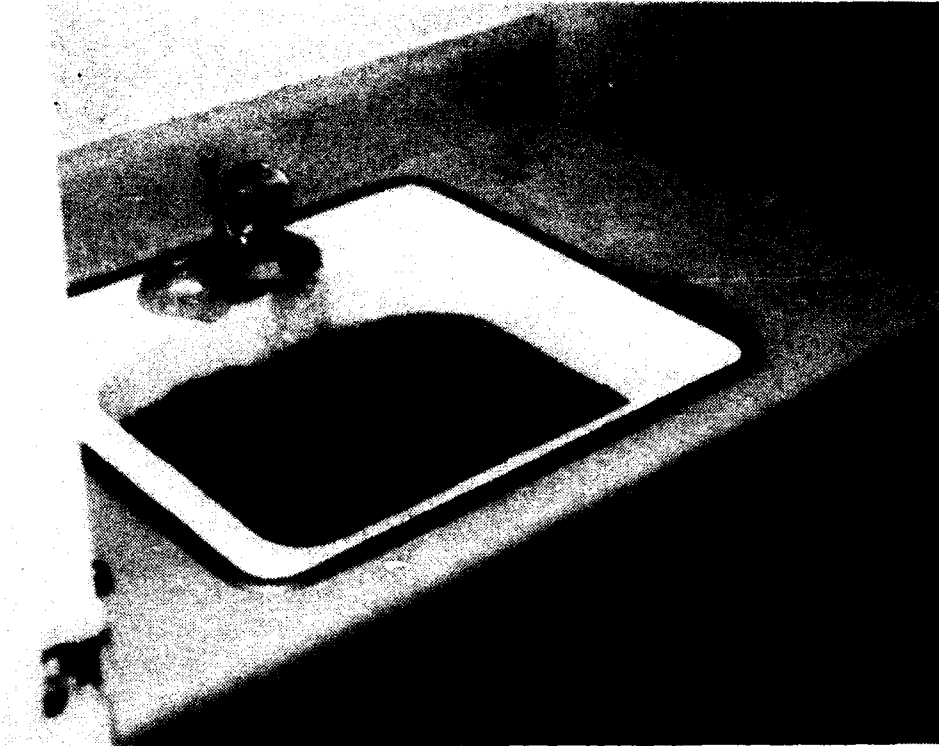
**Figure 28. Residue in Sink During System Flushing.**

During the course of the flushing process, appreciable amounts of greenish-colored, chloride-containing, copper corrosion products were observed in the toilets, sinks, and bath tubs. In the unit at 7375B Mindanao Court, a large amount of reddish brown residue was flushed from the pipes into the bathroom sink (Figure 28) and bath tub.

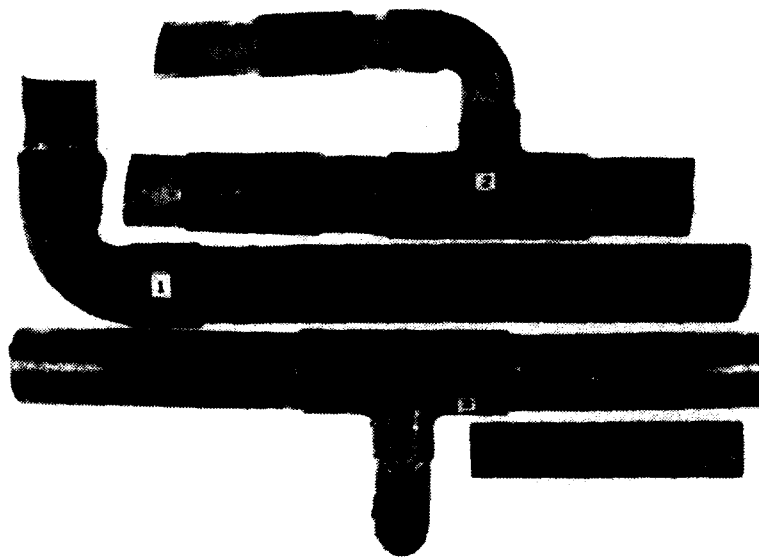
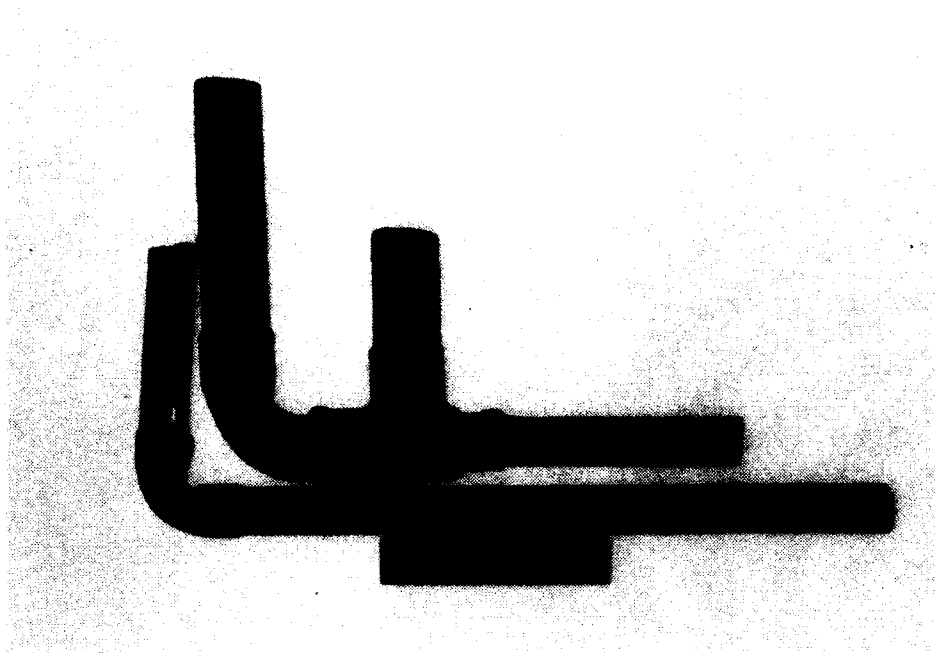
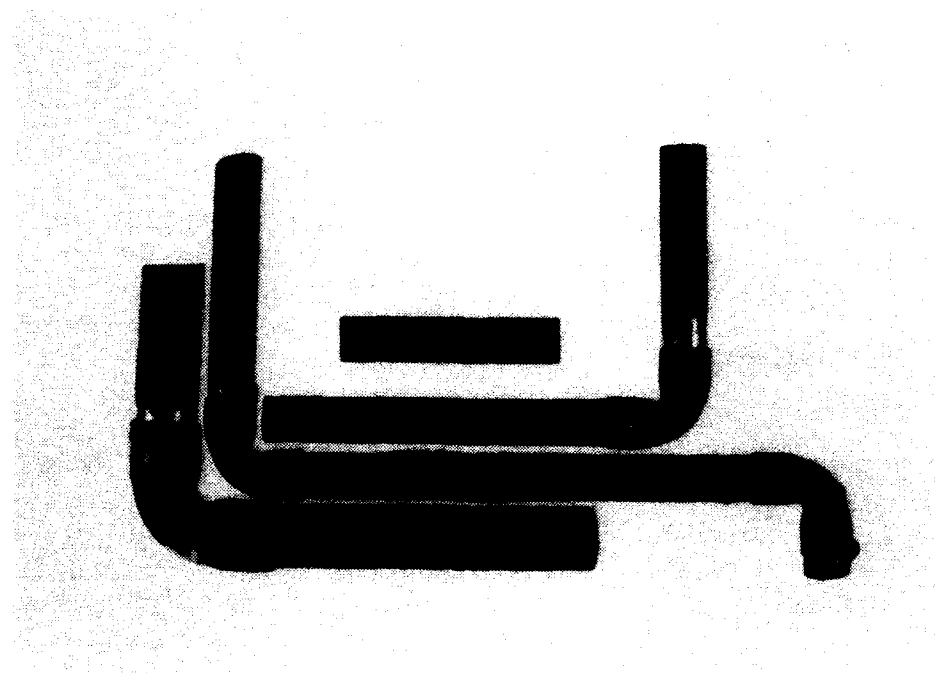
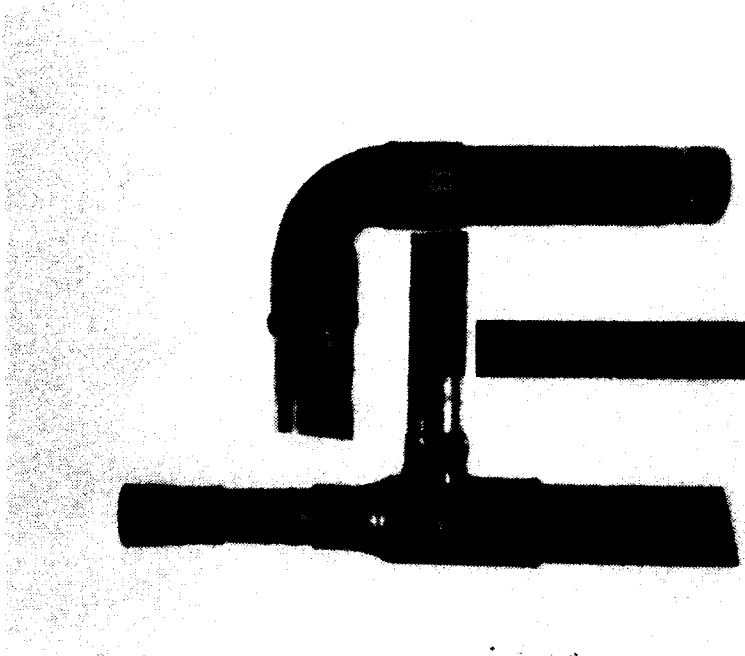
Examination of the outside surfaces of the copper tube/fitting specimens that were removed before and after the flushing revealed no significant deterioration by the external environment (Figures 29 through 32). Some chloride-containing, copper corrosion products were present, but only superficial corrosion of the underlying copper had taken place. This external corrosion had occurred, undoubtedly, because soldering flux residue had not been wiped from the outside surfaces of the tubes and fittings after the soldered connections had been made. The outside surface examination further revealed that several of the specimens had been overheated when the tubes were originally soldered to the fittings. The overheating was indicated by the near-black appearance of the tubes and fittings.

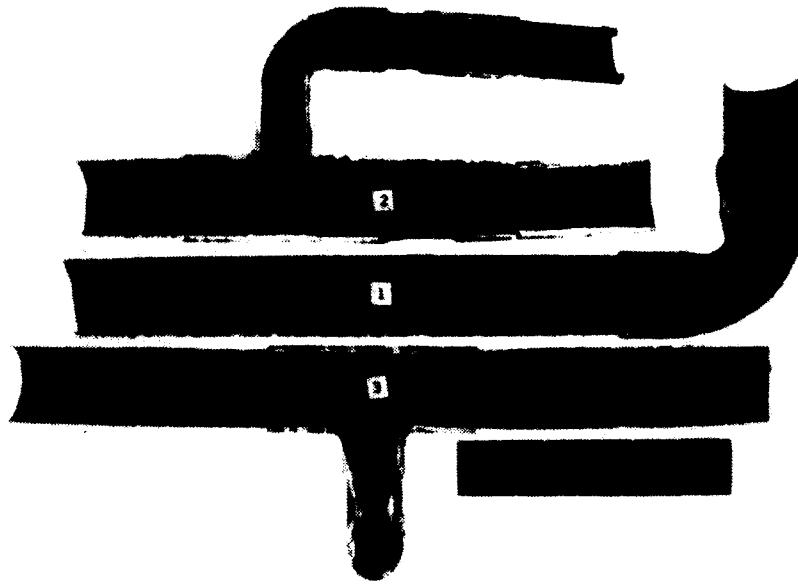
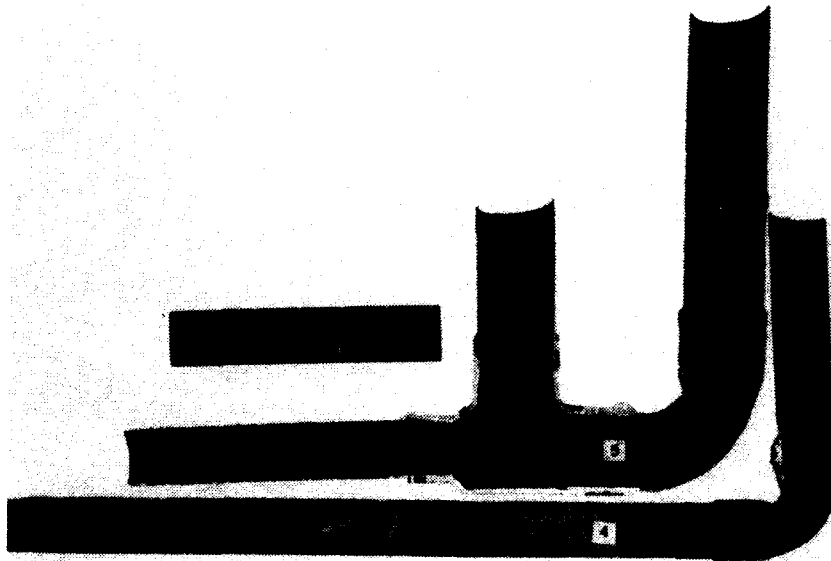
Examination of the inside surfaces of the tubes and fittings that had been removed before hot water flushing revealed that flux-induced corrosion had occurred inside four of the five specimens (Figures 33 and 34). The corroded areas contained porous, reddish brown, cuprous oxide, which was typically overlaid with friable, greenish-colored mounds (i.e., tubercles) of copper corrosion products.

Inside surface examination further revealed that very poor workmanship had been involved when the copper tube systems were originally installed. Evidence of this included: (1) tubes had not been fully inserted into fittings before soldering, (2) sticky, petroleum-base, soldering flux residue was on the inside surfaces in addition to the flux residue associated with the water-side corrosion, (3) solder was present on the water-side surfaces, (4) one tube from 7202A Baker Street was inserted too deeply into a fitting before soldering, and (5) soldered connections appeared black, which confirmed that the tubes and fittings had been overheated during the original soldering.

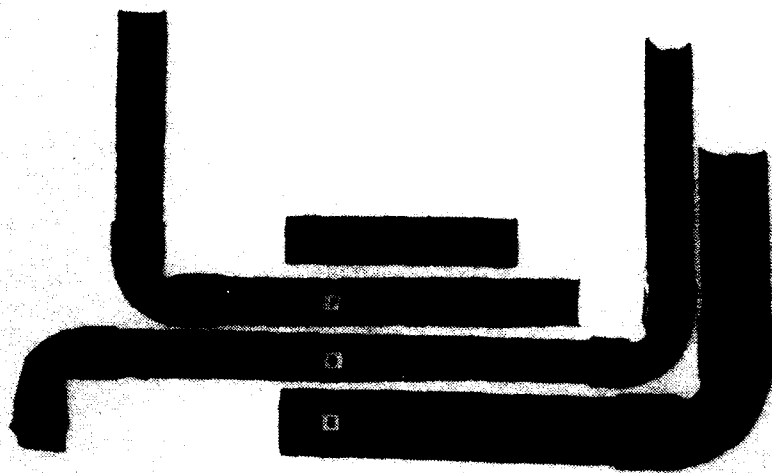
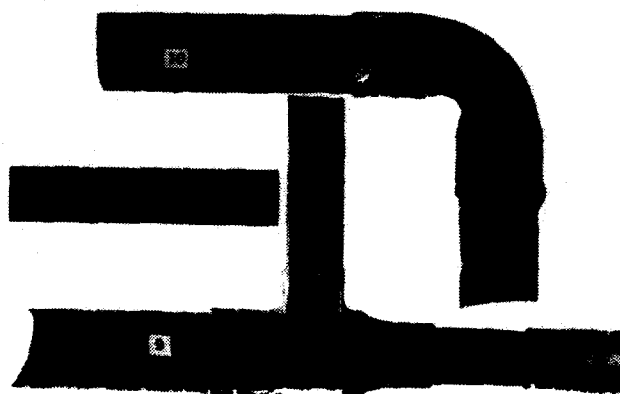
Examination of the inside surfaces of the tubes and fittings that had been removed after hot water flushing revealed that solder flux-initiated, localized corrosion had occurred on the water sides of all five samples (Figures 35 and 36). The samples looked similar to those taken before the hot water flushing with one exception: the specimen taken from 7315A Alexander Circle showed significant removal of the greenish-colored corrosion products.

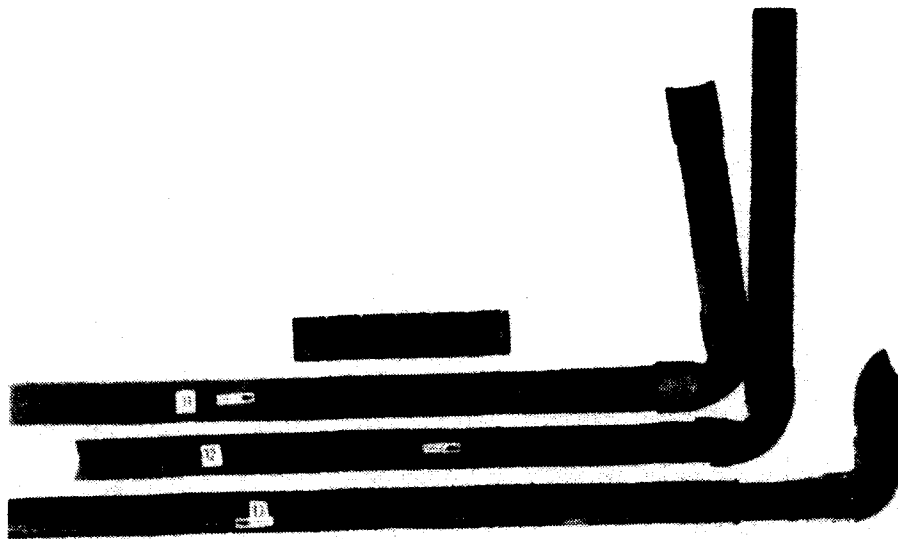
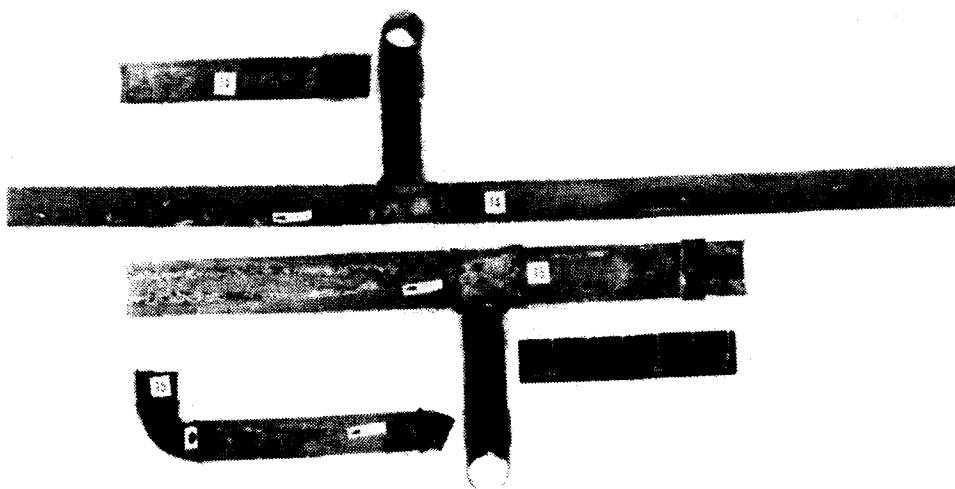
The outside surfaces of the pipes were examined first and no major deteriorations were discovered; the surfaces were either covered with solder or a protective tarnish film of reddish-brown, cuprous oxide. However, some outside surfaces were covered with chloride-containing, greenish-colored, copper corrosion products. Superficial corrosion had occurred at these locations that was most likely due to excess solder flux residue that had not been wiped off the outside surface of the pipes. The pipe specimens were then sectioned lengthwise to study the inside surface. The examination showed that some soldering flux-induced corrosion and greenish-colored copper corrosion products were present on the inside of all five specimens. The corrosion had occurred where the solder flux runs were located. The corrosion was most severe on the specimens from 7375B Mindanao Court and 7379C Mindanao Court. These two samples had pinhole perforations that contained reddish-brown, cuprous oxide in the pits. It was evident that the pits had occurred on the water-side because the diameters of the pits were larger on the water side than on the outside surface and because of the presence of the porous, reddish-brown cuprous oxide. None of the other specimens had pits that had propagated through the tube walls.

After examining the inside surfaces, it was again seen that poor workmanship existed when the copper pipe system was installed. Cut tube ends that had not been reamed/deburred before soldering, solder flux runs as long as 6 in., tubes that had not been fully inserted before soldering, and the black appearance of the soldered connection were some of the faults found in the pipe specimens. EDS was also performed on the five specimens collected. The EDS and microchemical analysis (MCA) showed that the copper corrosion products contained major quantities of copper, very minor to semi-major amounts of sulfur and iron, minor to semi-major quantities of silicon, and undetectable to minor amounts of chloride. The presence of the undetectable to minor amounts of chloride shows that the hot-water flushing has been at least somewhat successful in removing the chloride, which is primarily responsible for the

It can be concluded that (1) localized, soldering flux-induced corrosion had occurred on the water-side surfaces of all five specimens, (2) there had been poor workmanship when the copper tube systems were originally installed, and (3) the hot water flushing and subsequent flow of water has been somewhat effective in removing aggressive species from the solder on the water-side surfaces of the specimens.

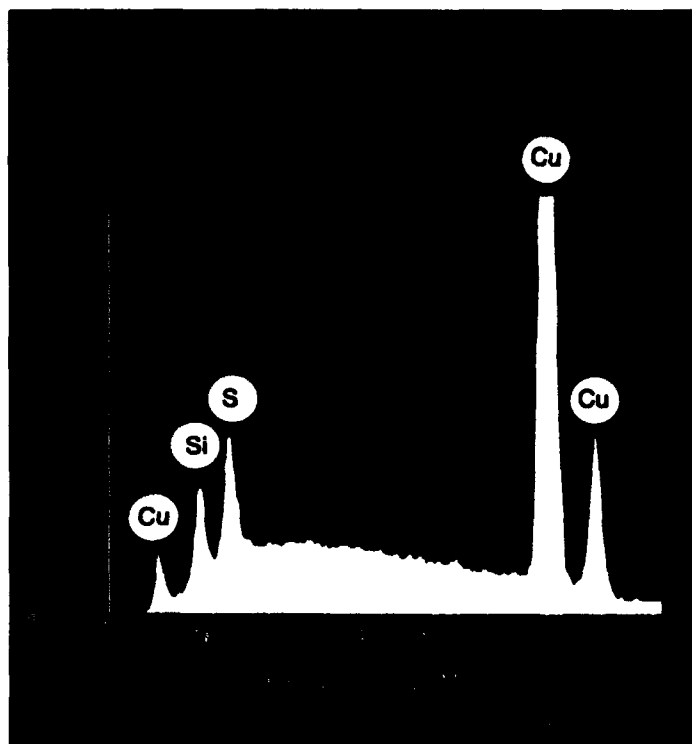
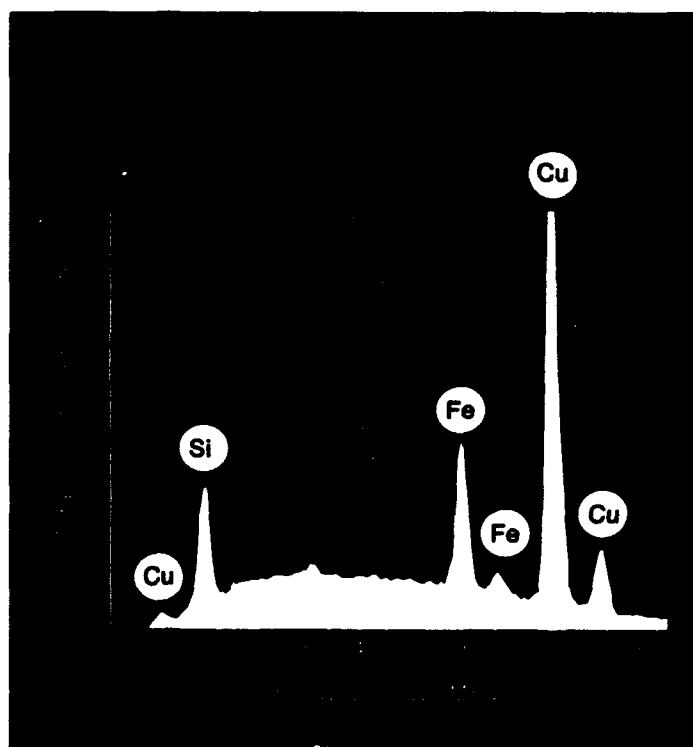
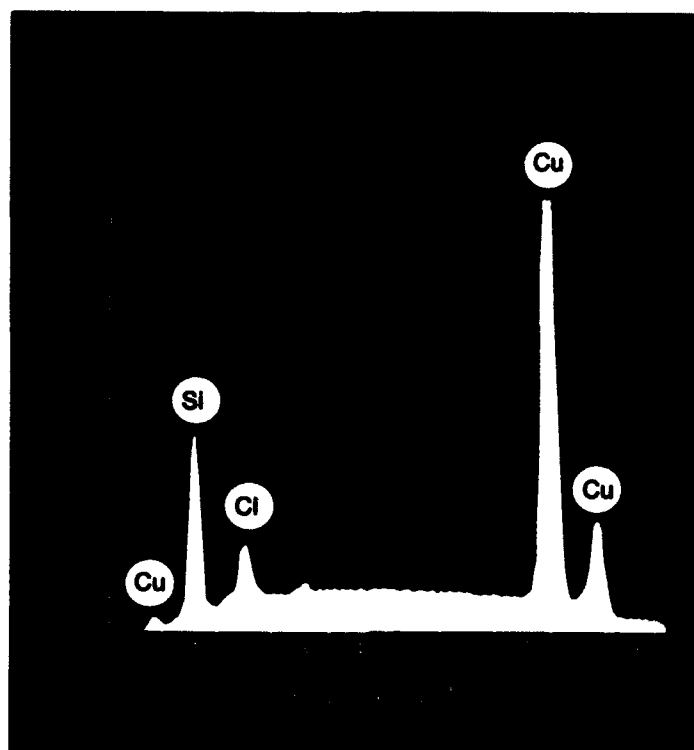
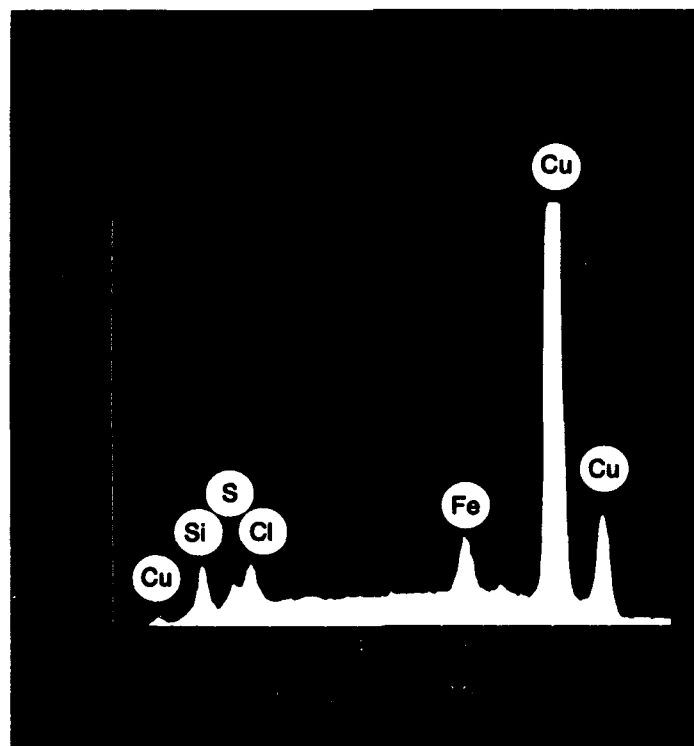
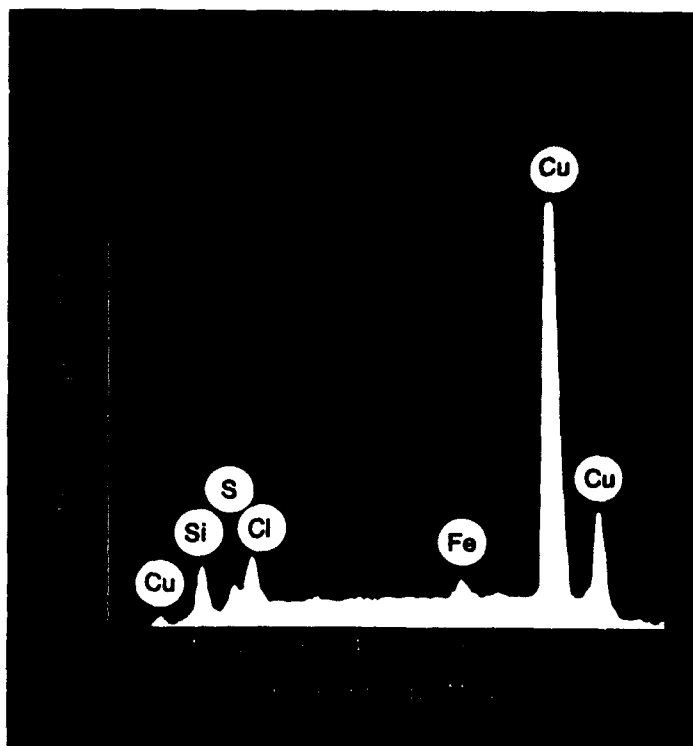
pitting. It was also seen from the EDS that no chlorides were detected in the corrosion-induced pits that are associated with the greenish-colored, copper corrosion products. The X-ray spectra for corrosion products removed (Figures 40 through 44), shows how much chloride was removed due to the hot-water flushing and the following 20 1/2 months of water flow through the pipes. See Table 11 for the summary of the percentages of chloride ions removed.
